WILDCARE – DESIGN REVIEW

76 Albert Park Lane, San Rafael CA

August 1, 2022

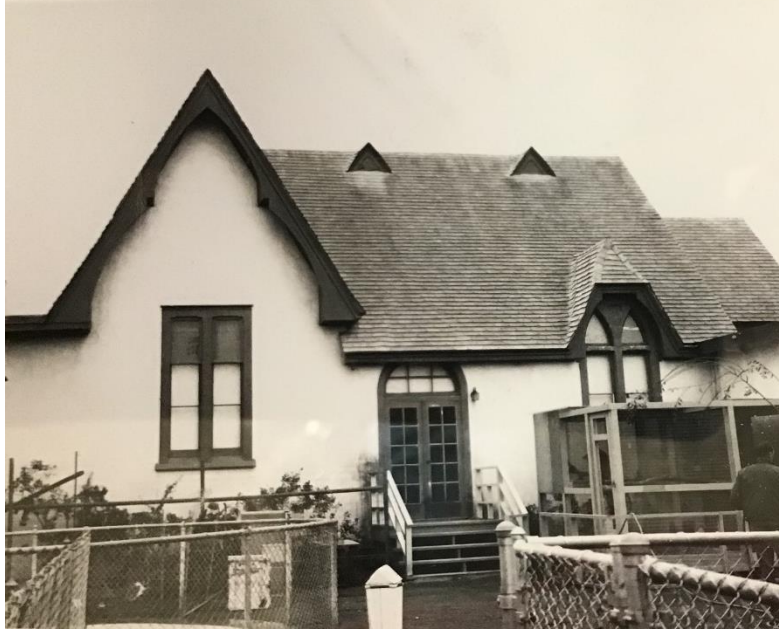
Parish hall shortly after moved to 76 Albert Park Lane, 1954, Marin County Free Library, California Room
